Cost savings using Derrick[®] Polyweb[®] dry urethane (DU) screens

Case Study 211: Polyweb Dry Screens Cost Savings- 10/17

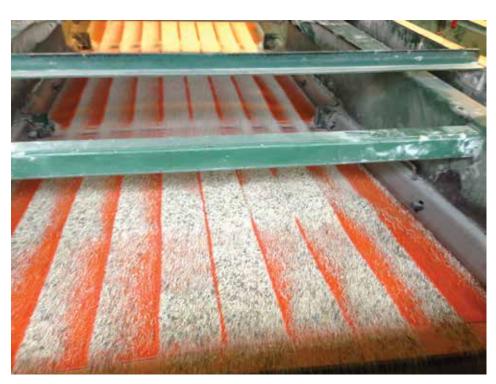
Polyweb DU panels classifying dry hydraulic fracturing sand

These Polyweb DU panels are available in both standard rectangular openings and "sq" square openings where the product specification requires holding a tolerance of less than 1 to 2 percent.

To solve the premature wear problem of wire screens, the customer installed Polyweb[®] DU panels on its 16 Derrick[®] Dry Sizers. These machines were in service for classifying dry hydraulic fracturing (fracking) sand. With the DU panels installed, the machines were able to run non-stop for 5 months with no lost production time due to panel changes. This factor alone increased total product output by over 10 percent!
